MODIFICATIONS TO THE SOIL PATTERN OF SOUTH-CENTRAL  
CHILE RESULTING FROM SEISMIC AND ASSOCIATED  
PHENOMENA DURING THE PERIOD  
MAY TO AUGUST 1960

BY CHARLES WRIGHT AND ARNOLDO MELLA

ABSTRACT

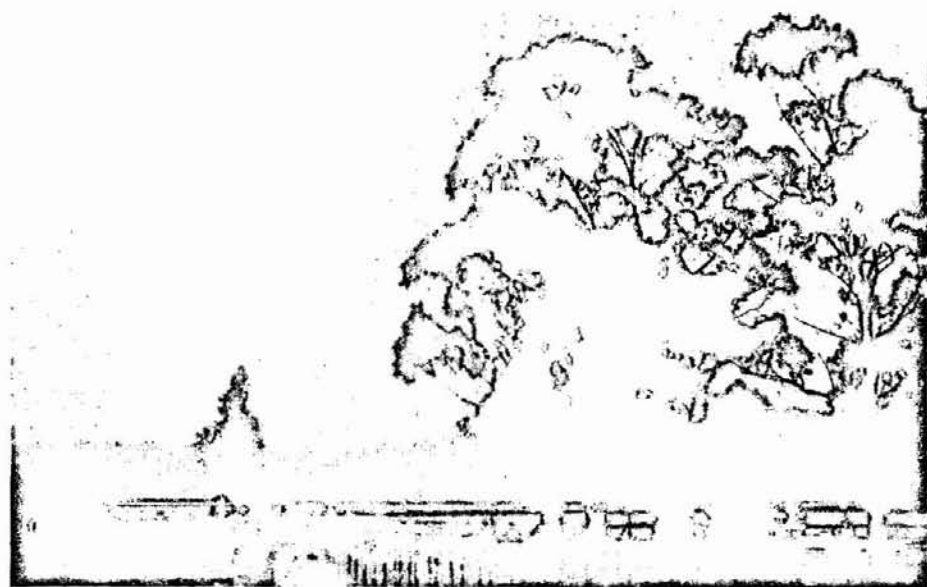
FIG. 3. Flooded Lowland Near Tolten Photographed on 2 June 1961. Twelve months later, the only differences noted were that the trees had died and a temporary access causeway had been constructed across the flooded plain.

Between the site of Tolten and the foothills of the coastal range, there is an area of low-lying land some 5 to 6 km wide, normally lying about 1 to 2 meters above the mean low tide level. On this part of the coastal plain, the soils are mottled peaty clays and peat loams. This lowland area filled with sea water at the time of the tsunamis, and after an initial flooding to a depth of 2 to 3 meters (in the deepest parts), there was only a recovery of 60 cm in the level during the succeeding 8 days. Most land-owners are convinced that the land has now sunk at least  $1\frac{1}{2}$  meters below its former

level (figure 3). They point out that the water on their land fluctuates regularly in depth by some 30 cm with the tides. Accurate measurement of the level of this land with respect to mean tide levels is in progress, but even today, 12 months after the earthquake, the land remains beneath a lake of brackish water.

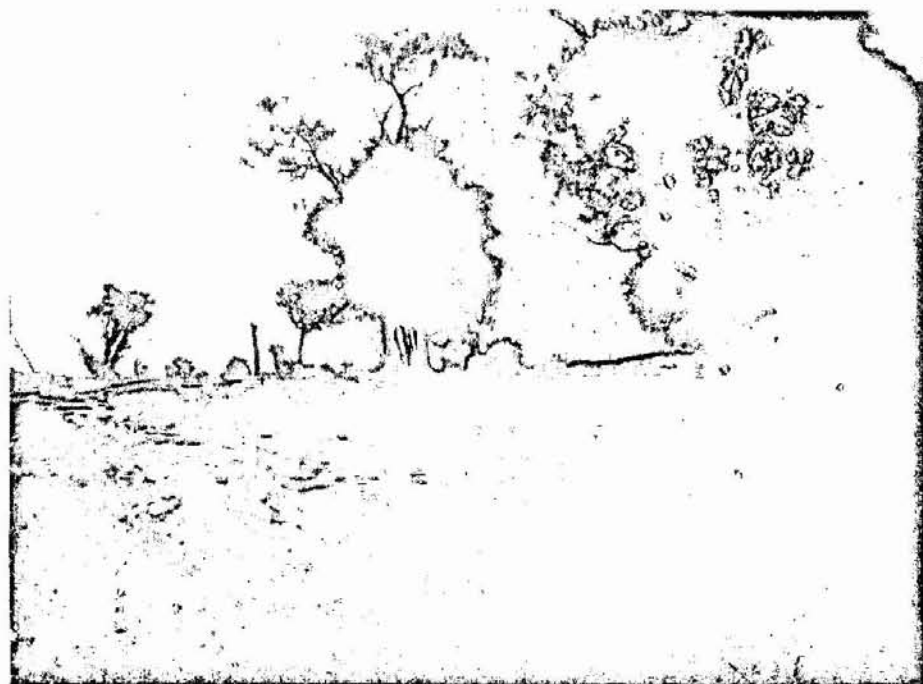
FIG. 4. Fissured Ground Near Tolten, Marking an Area of Subsidence Produced by Packing of Unconsolidated Peaty Sediments Below Alluvial Soil. (Photo L. Duharte)

lying alluvial material, marking out the limit of the area of subsidence (figure 4). Much of the Tolten and Boldo plains are underlain by similar peaty materials, and some of the apparent change in the level of the land may be due to local subsidence caused by the decomposed, peaty substrata being shaken into a more compact mass.

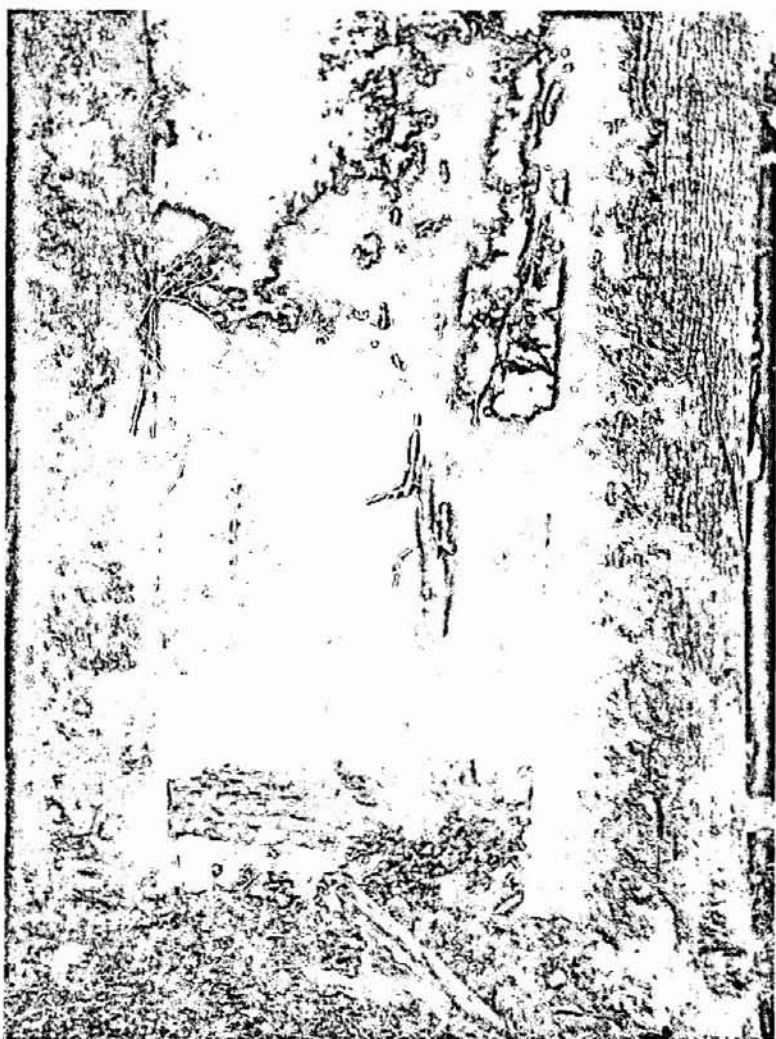
FIG. 11. Trees Near the Lakeside That Survived the Passage of a Mudflow. Note the bruised bark and mud-splattered trunks.

When the mudflows began to lose impetus as they traveled across the flat land, a few large trees managed to remain in place. The lower part of their trunks are still buried in debris, but their bark is bruised and mud-splattered (fig. 11) far

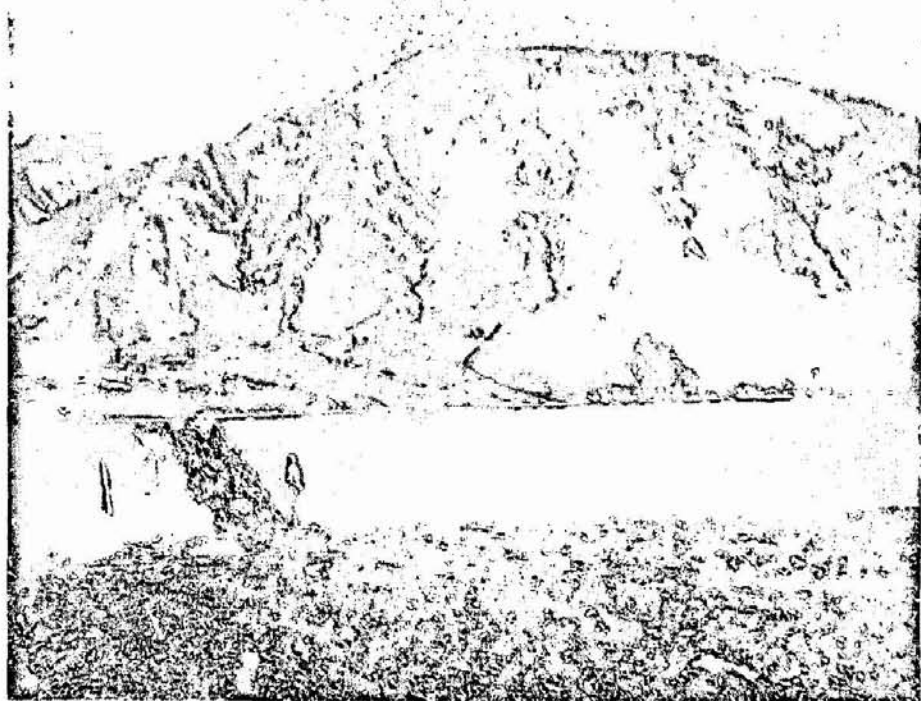
FIG. 12. The Edge of a Mudflow Where it Discharged Directly Into Lago Rupanco. Another large mudflow can be seen on the opposite side of the lake. The latter mudflow occupies the site of the destroyed agricultural settlement of Gaviota.

Much of the debris from the disaster surged directly into the lake (fig. 12) and created a wave that extended the damage around the lakeshore far beyond the area most seriously affected by avalanches and mudflows. Narrow sandy beaches
