# IDENTIFYING AND ASSESSING PROBLEM AREAS IN SOIL EROSION SURVEYS USING AERIAL PHOTOGRAPHS

By R. G. B. JONES and M. A. KEECH

*Land Use Planning Section, Department of Conservation and Extension, Rhodesia*

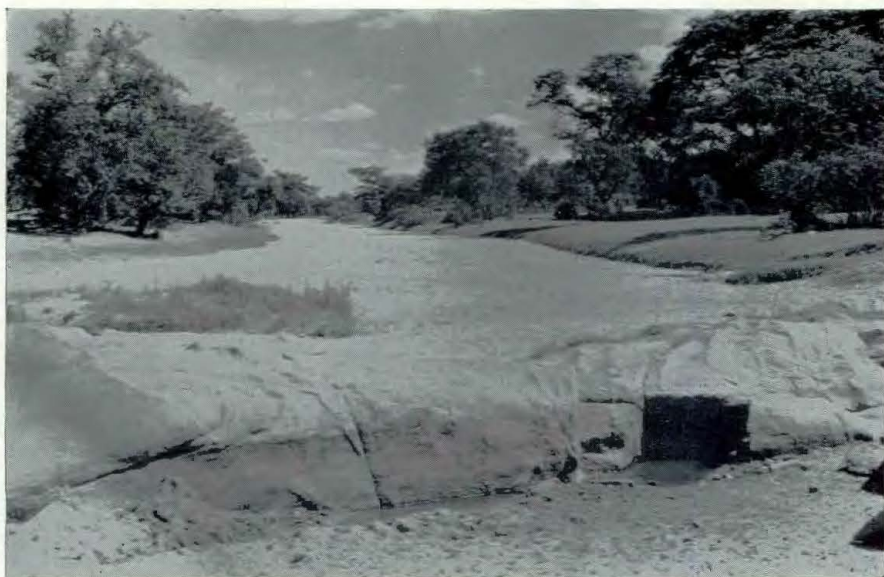
FIG. 2. An upstream ground view of a stream-bed filled with sand from a badly eroded portion of the Tokwe river catchment in Chibi Tribal Trust Land.

Where gullying was intensive the rivers, as one would suspect, were full of sand. This, too, was identifiable in the stereoscopic image (Figs. 2, 3 and 4).

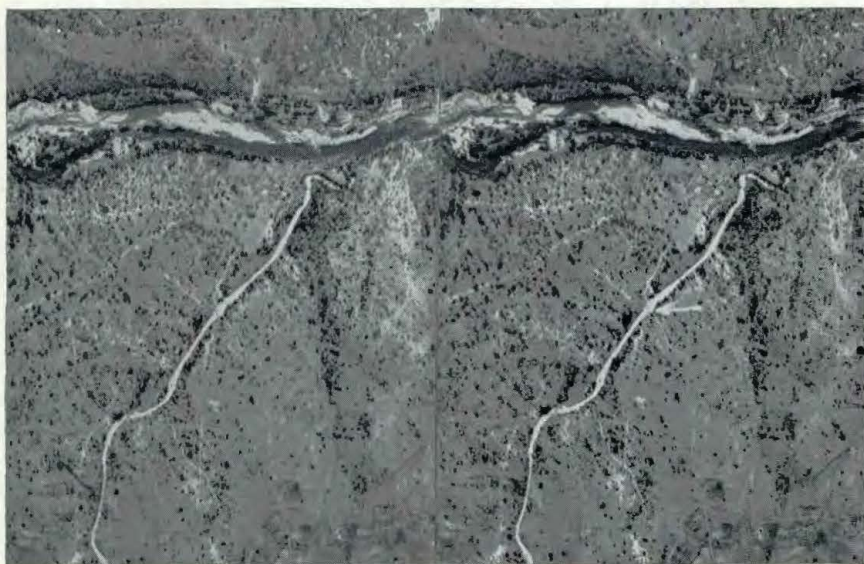
FIG. 3. Vertical stereogram of the same sand-filled streambed. The point of the arrow indicates the crossing-point on the stream where the ground photograph (Fig. 2) was taken. Photo-scale: 1/25,000.

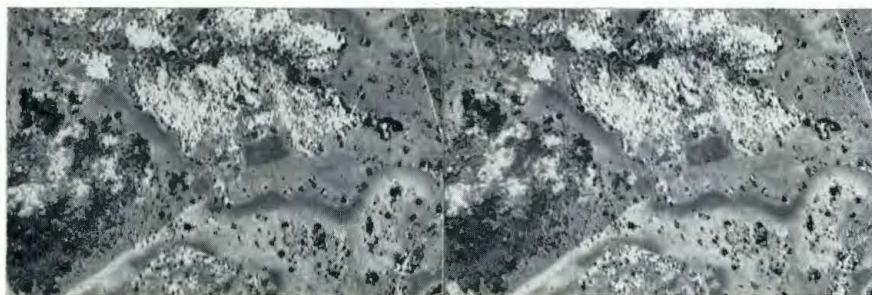
FIG. 5. Vertical stereogram showing typical appearance (white patches) of Solonetz soil conditions under *Colophospermum mopane* in the middle veld area of Rhodesia. Photo-scale: 1/25,000.

Although solonetz soil conditions under *Colophospermum mopane* vegetation have a very characteristic appearance on aerial photographs, showing up as a rash of black-and-white spots with low antheaps and bare areas of sheet erosion (Fig. 5), gully identification and classification were seldom possible in these areas.
